Infrared Inspection Samples

<b>Thermography Inspection at (Site)</b>	<b>Date: (date)</b>
---	--	-------------------------

**Summary of Inspection**

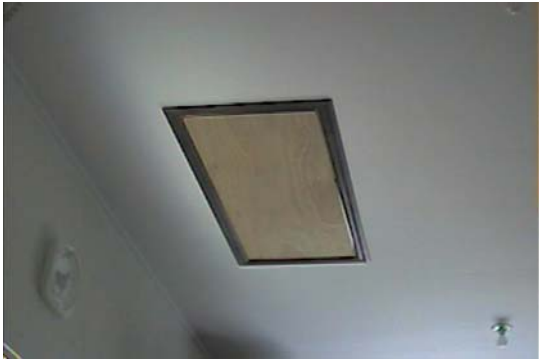
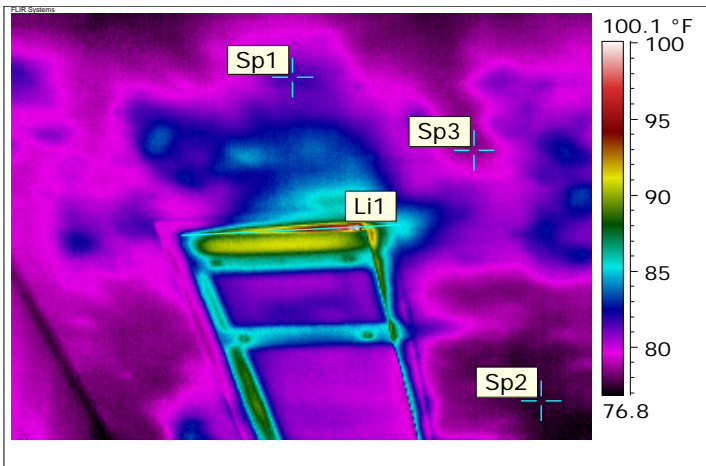
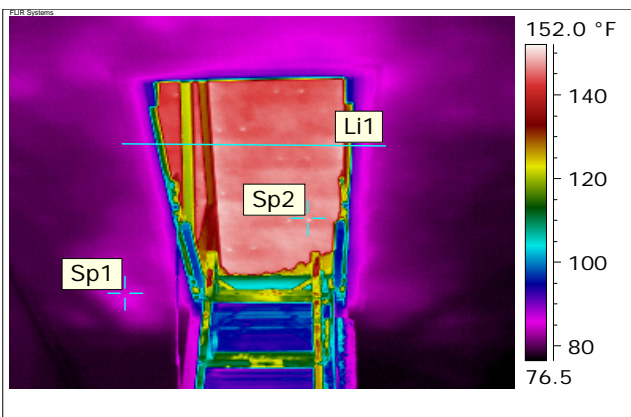
IR Text Comment	Value
Location	Residential Home
Category	Energy/Missing Insulation

This series of pictures shows the door leading to the attic closed and open. While it's closed heat is still leaking into the room. The door should be checked to make sure it is flush with the frame and/or more insulation should be added.

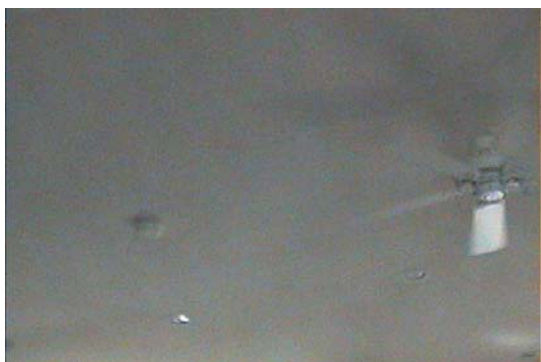
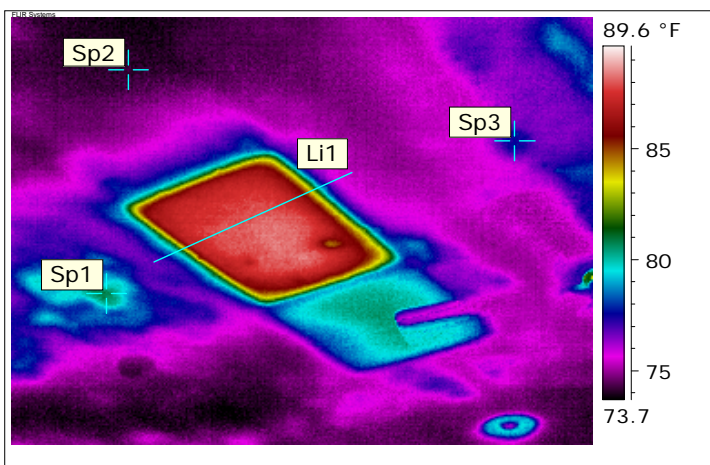
IR Text Comment	Value
Location	Residential Home
Category	Energy/Missing Insulation

This picture shows a section of the ceiling drywall that was repaired but the insulation was not replaced in the attic.. Insulation should be replaced above the repaired section.

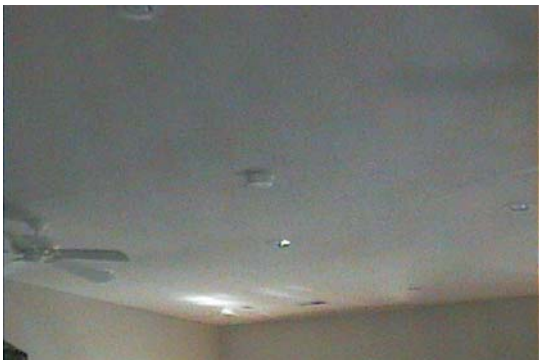
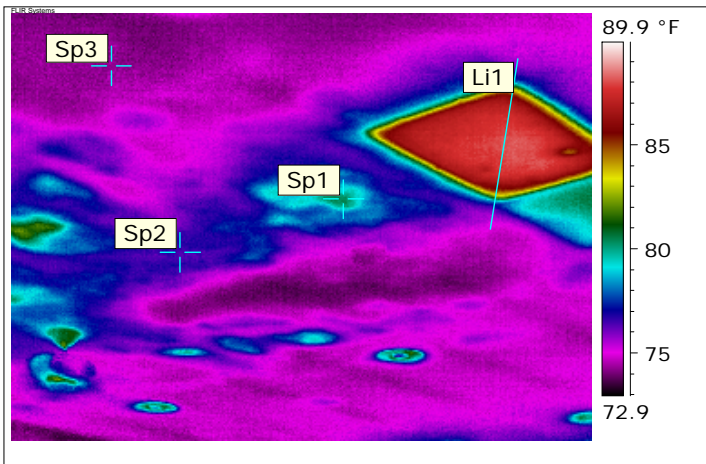
IR Text Comment	Value
Location	Residential Home
Category	Energy/Missing Insulation

Another view of the a repaired ceiling where insulation was not replaced in the attic. Insulation should be replaced in the attic.

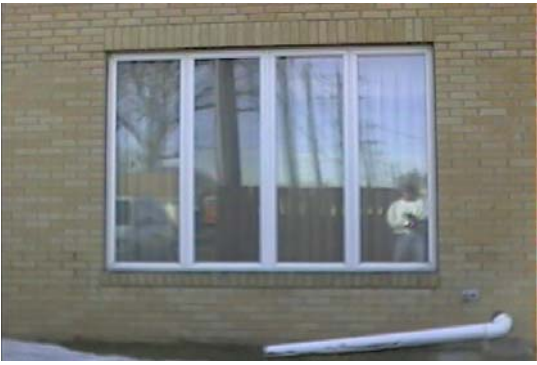
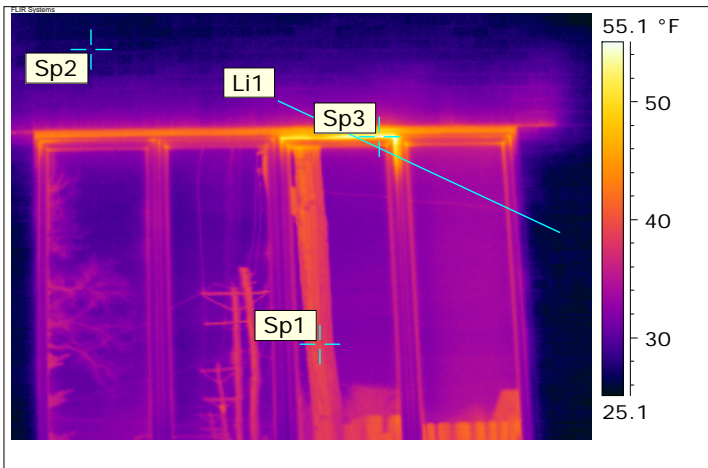
IR Text Comment	Value
Location	Commercial Building
Category	Energy/Window

This picture shows a window at a commercial building. Window seals should be inspected and replaced to prevent energy loss and or water from seeping in through the gap.

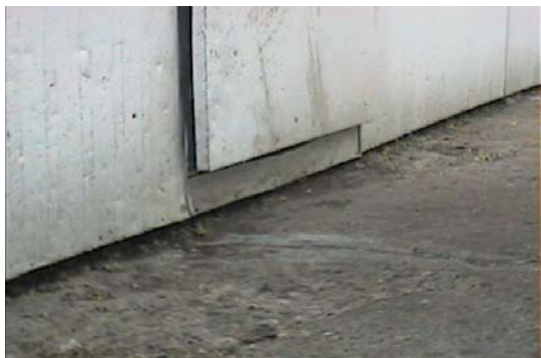
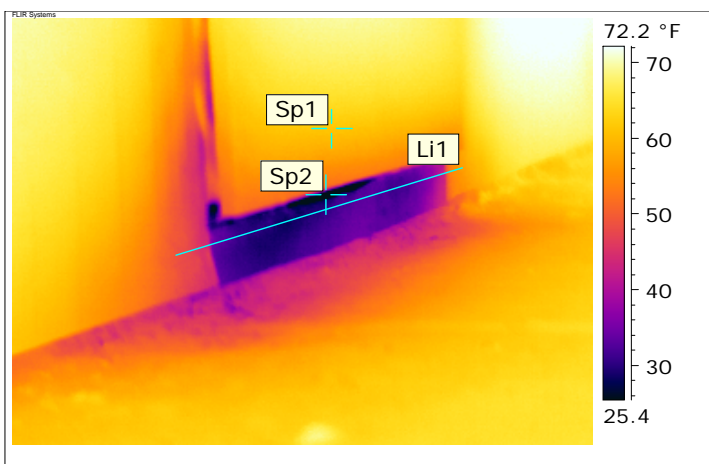
IR Text Comment	Value
Location	Commercial Building
Category	Energy/Insulation

This picture shows the door to an outdoor walk in freezer. The door seals should be inspected and replaced to prevent energy loss.

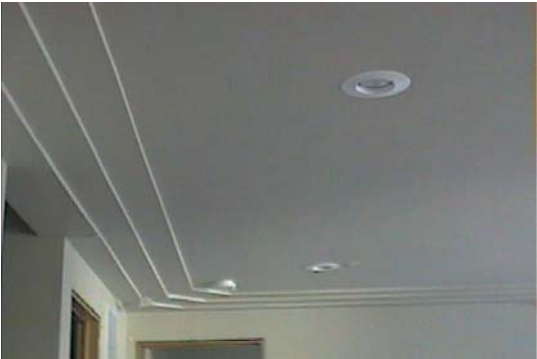
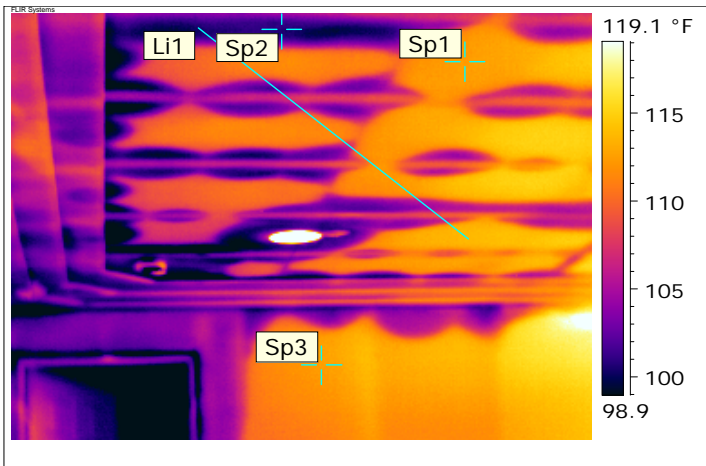
IR Text Comment	Value
Location	Residential Home
Category	Water Damage/High Heat Unit

This picture shows the basement ceiling of a residential home. The dark spots is moisture from water pipes that broke in the main floor ceiling. The house was dried with minimal drywall tear out utilizing the Dry-Vex High Heat Unit. **NOTE: Infrared Maximum temperature is due the recessed light being on.**

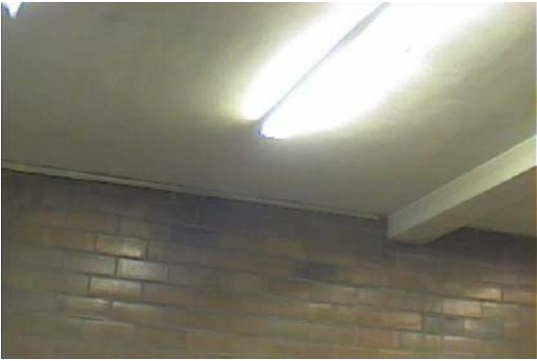
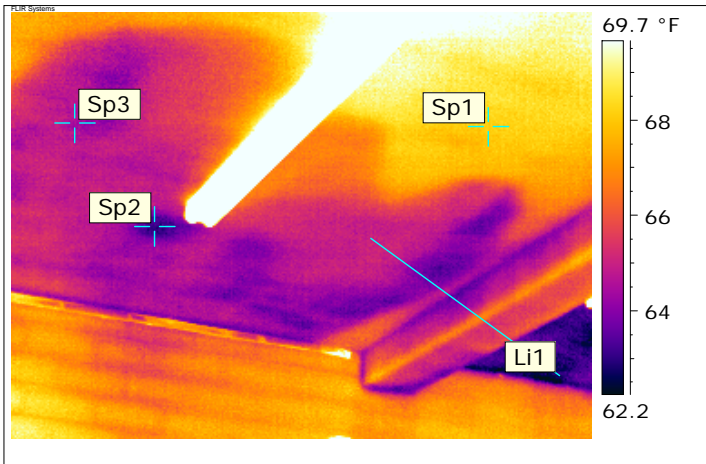
IR Text Comment	Value
Location	Commercial Building
Category	Water Damage/High Heat Unit

This picture shows a plaster ceiling in a commercial building. Darker areas are moisture. This ceiling and the rest of the building was dried with no tear out of walls, ceilings or carpet utilizing the Dry-Vex High Heat Unit. This picture was taken on January 22<sup>nd</sup> 2008, one day before the next picture.

**NOTE: The Infrared Maximum temperature is due to the fluorescent light fixture in the picture.**

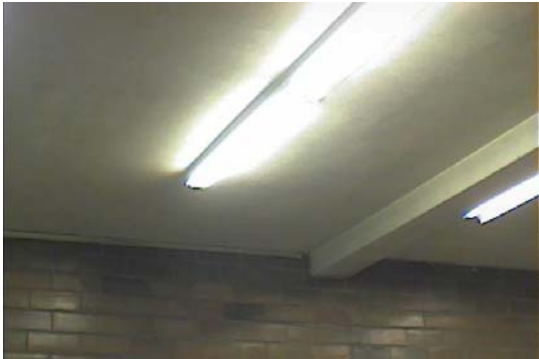
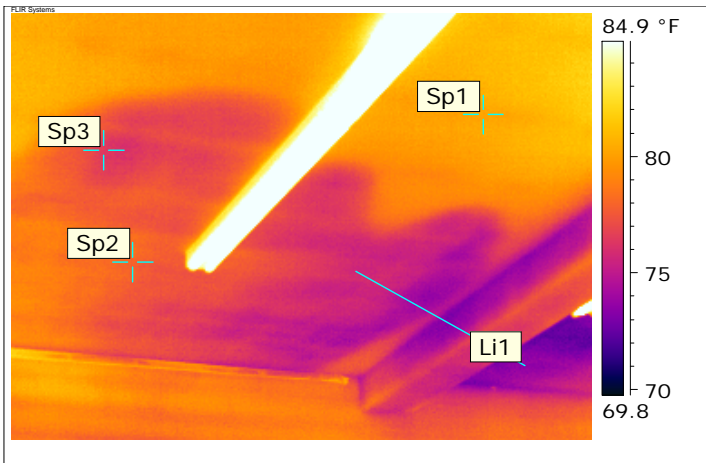
IR Text Comment	Value
Location	Commercial Building
Category	Water Damage/High Heat Unit

This picture shows a plaster ceiling in a commercial building. Darker areas are moisture. This ceiling and the rest of the building were dried with no tear out of walls, ceilings or carpets utilizing the Dri-Vex High Heat Unit. This picture was taken on January 23<sup>rd</sup> 2008 one day after the previous picture.

**NOTE: The Infrared Maximum temperature is due to the fluorescent light fixture in the picture.**

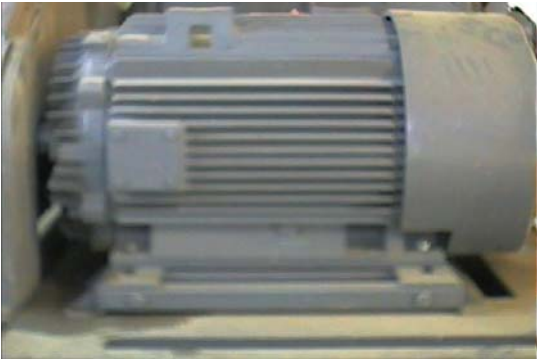
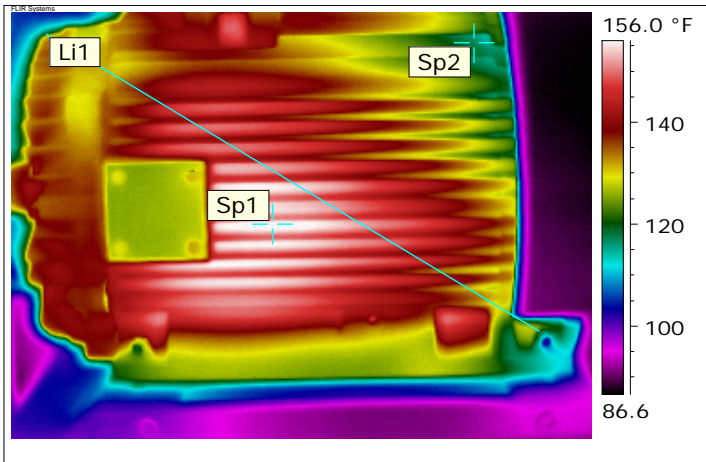
IR Text Comment	Value
Location	Commercial Building
Category	Mechanical

This picture shows an electric motor. Infrared inspections can show wear patterns and can be used in a preventative maintenance program.

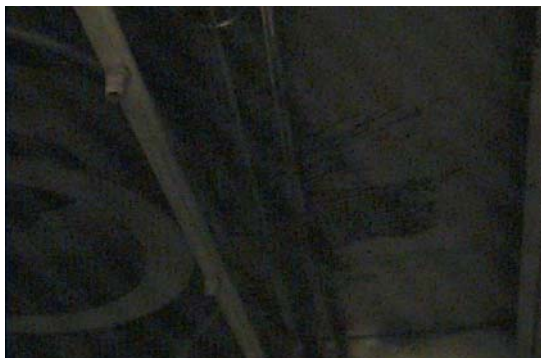
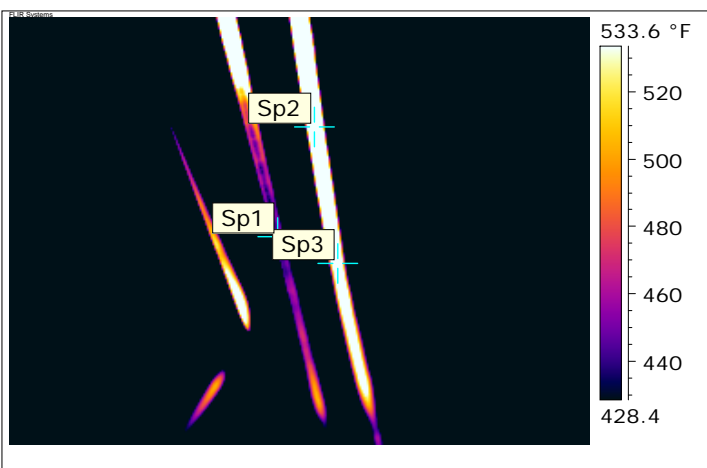
IR Text Comment	Value
Location	Commercial Building
Category	Mechanical/Conductive Heat Element

This picture shows the inside of a walk in smoke house. The conductive heating element is on and the darker areas indicate a much lower temperature than the brighter areas. The heating element should be inspected and repaired or replaced.

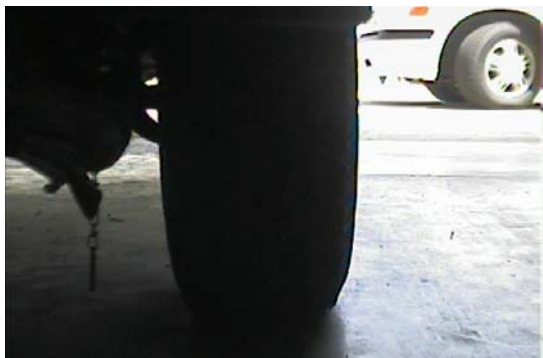
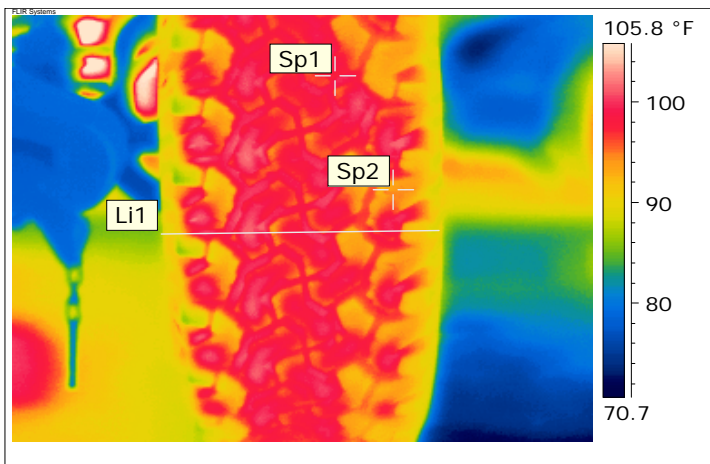
IR Text Comment	Value
Location	Shop
Category	Tire Inspection

This picture shows the driver's side tire on a Jeep. Compare with passenger side tire below. This type of inspection can be used as a part of a preventative maintenance program.

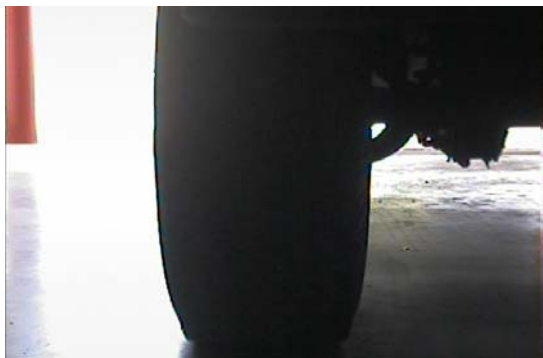
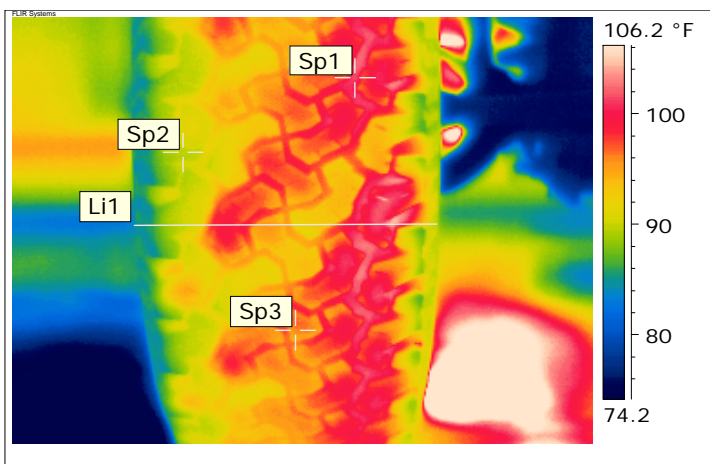
IR Text Comment	Value
Location	Shop
Category	Tire Inspection

This picture shows the passenger side tire on a Jeep. The unusual heat patterns indicate unusual wear which could be due to improper inflation or tire imbalance. This type of inspection can be used as a part of a preventative maintenance program.
