Infrared Inspection Samples

<b>Thermography Inspection at (Site)</b>	<b>Date: (date)</b>
---	--	-------------------------

**Summary of Inspection**

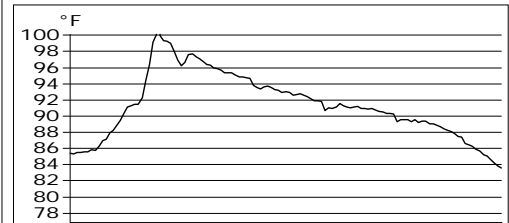
This series of pictures shows the door leading to the attic closed and open. While it's closed heat is still leaking into the room. The door should be checked to make sure it is flush with the frame and/or more insulation should be added.

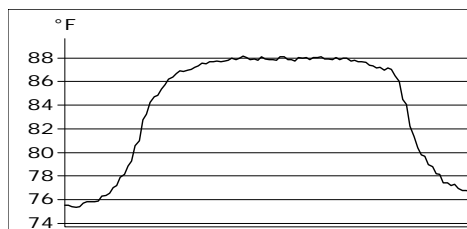
This picture shows a section of the ceiling drywall that was repaired but the insulation was not replaced in the attic.. Insulation should be replaced above the repaired section.

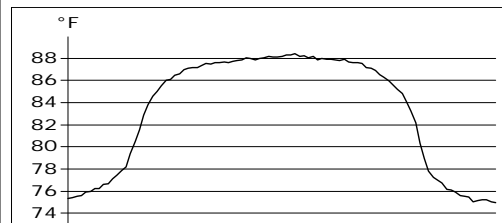
Another view of the a repaired ceiling where insulation was not replaced in the attic. Insulation should be replaced in the attic.

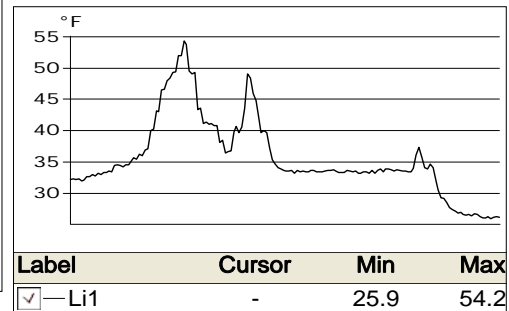
This picture shows a window at a commercial building. Window seals should be inspected and replaced to prevent energy loss and or water from seeping in through the gap.

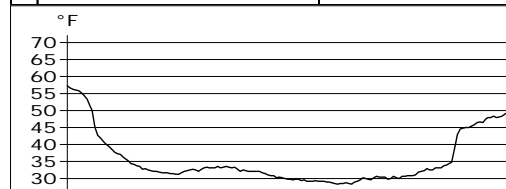
This picture shows the door to an outdoor walk in freezer. The door seals should be inspected and replaced to prevent energy loss.

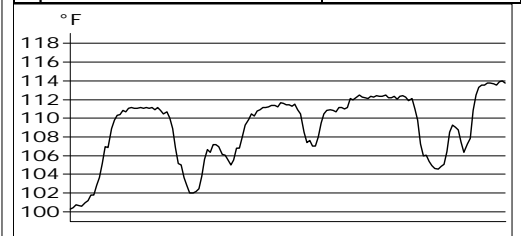
This picture shows the basement ceiling of a residential home. The dark spots is moisture from water pipes that broke in the main floor ceiling. The house was dried with minimal drywall tear out utilizing the Dry-Vex High Heat Unit. **NOTE: Infrared Maximum temperature is due the recessed light being on.**

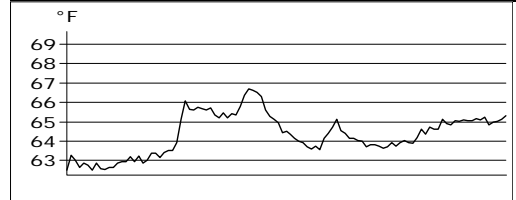
This picture shows a plaster ceiling in a commercial building. Darker areas are moisture. This ceiling and the rest of the building was dried with no tear out of walls, ceilings or carpet utilizing the Dry-Vex High Heat Unit. This picture was taken on January 22<sup>nd</sup> 2008, one day before the next picture.

**NOTE: The Infrared Maximum temperature is due to the fluorescent light fixture in the picture.**

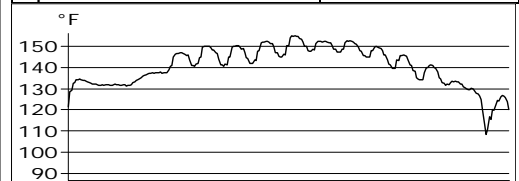
This picture shows an electric motor. Infrared inspections can show wear patterns and can be used in a preventative maintenance program.

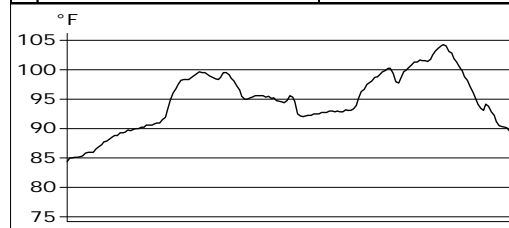
This picture shows the passenger side tire on a Jeep. The unusual heat patterns indicate unusual wear which could be due to improper inflation or tire imbalance. This type of inspection can be used as a part of a preventative maintenance program.
